Home Inspection Report

1234 School House Road
Yourtown, US 12345

Prepared for: Bob Smith

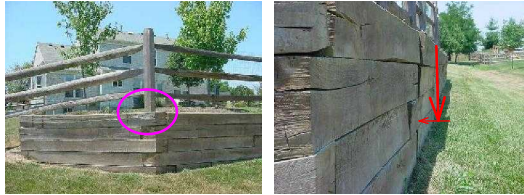
Retaining Walls: Railroad ties The wall is showing signs of movement, but appears stable at this time. Recommend an estimate by a qualified contractor to evaluate, estimate, and recommend repairs that may be required to maintain the retaining wall.

Grading: moderate The grade and landscaping materials are too high and extend above the window well at the Northeast rear of home. Recommend that the grade be reduced or the window well metal soil retainer be replaced with a taller soil retainer to keep the mulch and soil from washing into the window well.

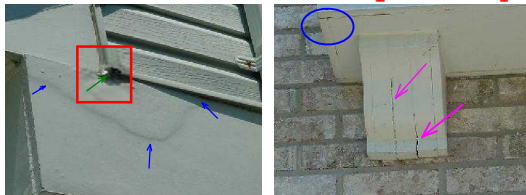
1. The wood window boxes have water damage and will require repair/replacement. The wood has started to separate at the supports and at the corners of the window boxes.

2. The trim board at the southwest corner of the porch has water damage due to water penetration and will require repair/replacement of the wood. The trim board extends out creating a ledge allowing water to collect on the top edge of the board and cause the wood to rot.

Recommend estimate/repairs by a qualified contractor.

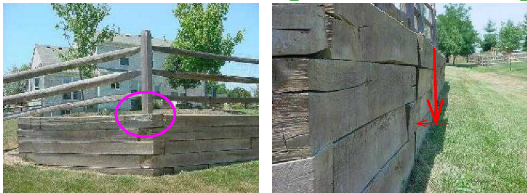
1. **Retaining Walls:** Railroad ties The wall is showing signs of movement, but appears stable at this time. Recommend an estimate by a qualified contractor to evaluate, estimate, and recommend repairs that may be required to maintain the retaining wall.

2. **Grading:** moderate The grade and landscaping materials are too high and extend above the window well at the Northeast rear of home. Recommend that the grade be reduced or the window well metal soil retainer be replaced with a taller soil retainer to keep the mulch and soil from washing into the window well.

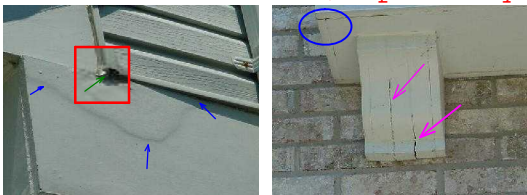
1. The wood window boxes have water damage and will require repair/replacement. The wood has started to separate at the supports and at the corners of the window boxes.

2. The trim board at the southwest corner of the porch has water damage due to water penetration and will require repair/replacement of the wood. The trim board extends out creating a ledge allowing water to collect on the top edge of the board and cause the wood to rot.

Recommend estimate/repairs by a qualified contractor.
